Metallurgical residues and structures from an evaluation at Llynfi Ironworks, Maesteg

Dr T.P. Young

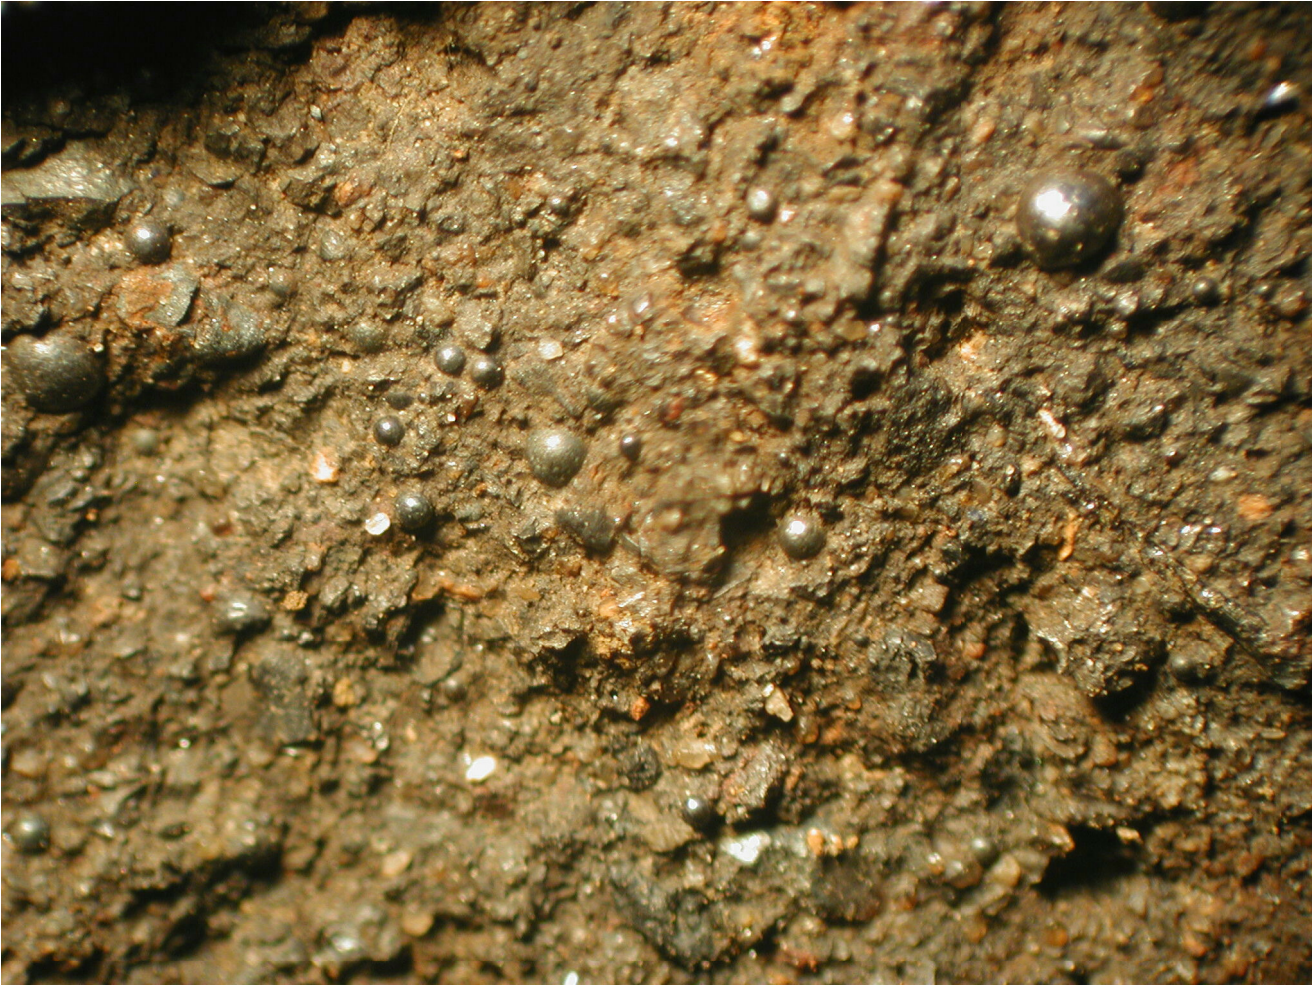
Figure 1. Photomicrograph of an area of approximately 8mm x 11mm of a sample of concretionary material from context 305. The photograph shows the abundance of spheroidal hammerscale.

Most significantly, the finer grained parts of the deposit contain a large proportion of slag spheres (spheroidal hammerscale) as shown in Figure 1. These spheres are mostly in the range of 100-600µm in diameter, with a hard, shiny exterior. This material is most likely to represent spatter produced by a power-hammer (probably during the production of wrought iron from puddled blooms).
